# Manhole Inspection Summary

Manhole # S71Q\_\_004MH

**Location** Address: **6717 Roberts Ave.**

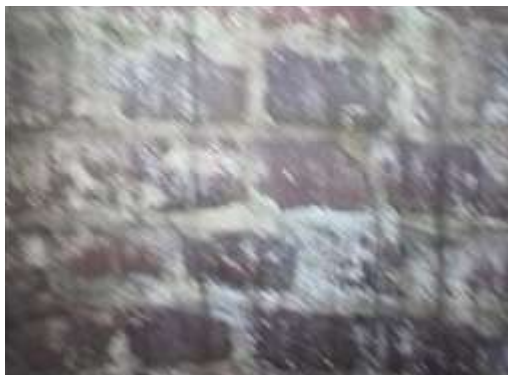
Defect 4

**Corbel** Material: **Brick** ☐ Parged Type: **Concentric/Eccentric**

Condition: ☐ Sound ☐ Cracked ☐ Root Intrusion ☐ Loose Brick ☒ **Deteriorated**

Infiltration: ☐ None ☐ Joint ☐ Cracks ☒ **Mortar** ☐ Roots ☐ Wall

**Barrel** Material: **Brick** ☐ Parged

Infiltration of mortar, joints, and wall of corbel--barrel

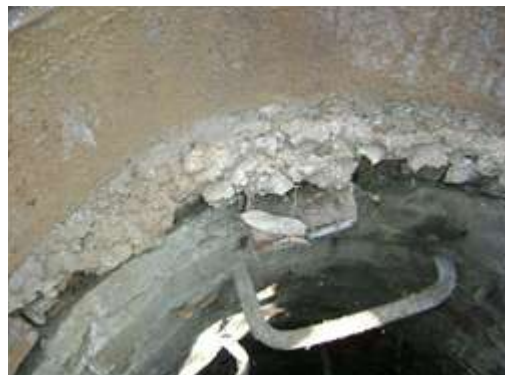
Defect 1

**Frame** Offset: **0** (in.) Condition: ☐ Sound ☒ **Cracked** ☐ Leaks

Deterioration under frame

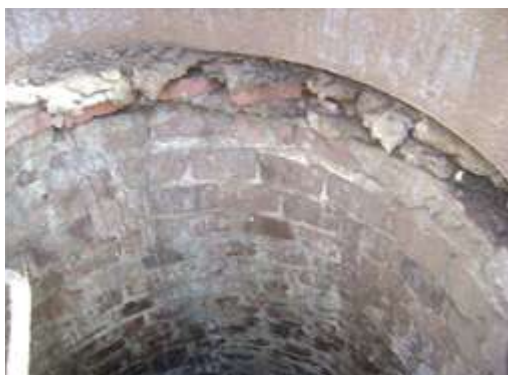
Defect 3

**Chimney / Frame Adjustment** ☒ Exists Material: **Brick** ☐ Parged Height: **8** (in.)

Condition: ☐ Sound ☐ Cracked ☐ Root Intrusion ☒ **Loose Brick** ☒ **Deteriorated**

Infiltration: ☐ None ☒ **Joint** ☐ Cracks ☐ Mortar ☐ Roots ☐ Wall

Infiltration of chimney from deterioration of mortar and joints.

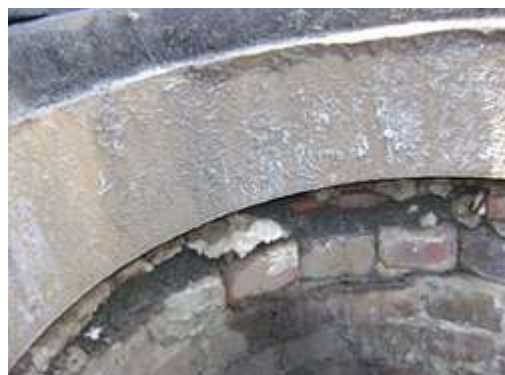
Defect 2

Loose Bricks-top of chimney under frame.

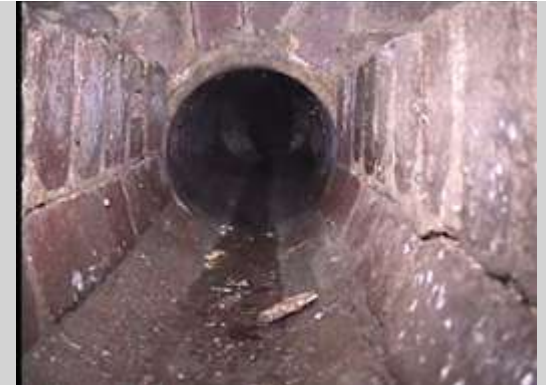
12 O'Clock Outflow

8 in. Circular Gravity Sewer  
Pipe Out @ 12 O'Clock

Pipe Height: **8.4** (in.) Rod and Bar (Angled)  
Pipe Material: **Clay** ☐ Pipe Lined  
Invert Depth: **8.50** (ft.) Flow Characteristics: **Slow**  
Deposits: ☒ None ☐ Mud ☐ Sludge ☐ Debris ☐ Grease  
Silt Depth: (in.) Deposits Extent:  
Infiltration: **None** Pipe Seal Cond: **Sound**

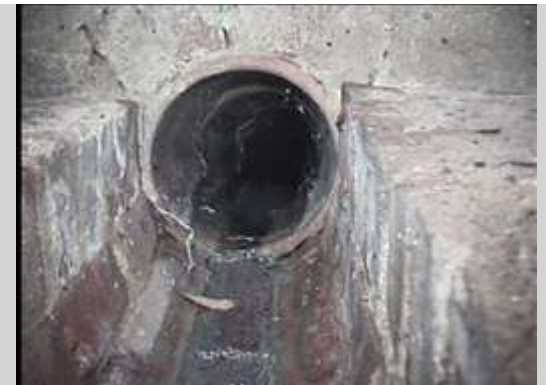
6 O'Clock Inflow

8 in. Circular Gravity Sewer  
Pipe In @ 6 O'Clock

Pipe Height: **8.4** (in.) Rod and Bar (Angled)  
Pipe Material: **Clay** ☐ Pipe Lined  
Invert Depth: **8.25** (ft.) Flow Characteristics: **Slow**  
Deposits: ☒ None ☐ Mud ☐ Sludge ☐ Debris ☐ Grease  
Silt Depth: (in.) Deposits Extent:  
Infiltration: **None** Pipe Seal Cond: **Sound**
